The Effects of Track Stability on Point Systems; Page One

Written by F.M . Spowart
Retford Pointcare Team Leader
21st January 2009.
Ver2

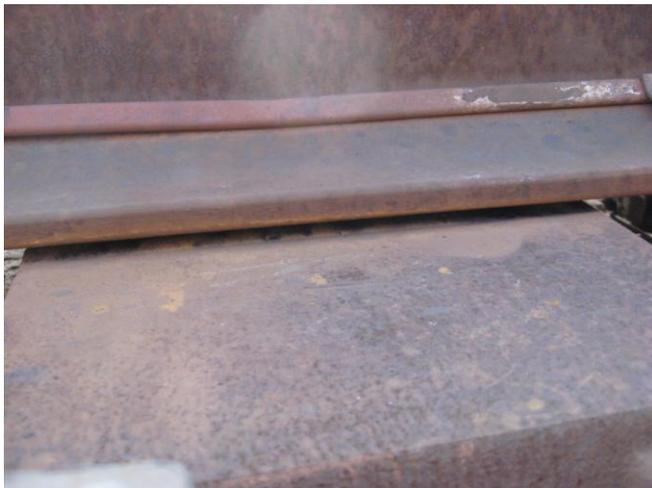
Voiding causes the switch rail to ride unevenly on the slide chairs, this will either slow the points considerably or completely disable them if associated with dry slides.

Where the switch rail is not riding on the slide chairs this is known as 'Hogging'.

Figure 1: Switch rail not sat on slide chair in closed position.

The rectification of voiding is by lifting and packing or kangoing requiring return visits or by permanent repair using a tamping machine, however, the hire of a tamper can be expensive and therefore manual packing is the preferred method.

The lifting and packing method is done by using a super-elevation gauge and slewing jack, and using small chippings to put under the timbers to create a firm bed.

Kangoing is the best manual option, as this pushes existing ballast firmly under the timbers and is less likely to require a return visit.

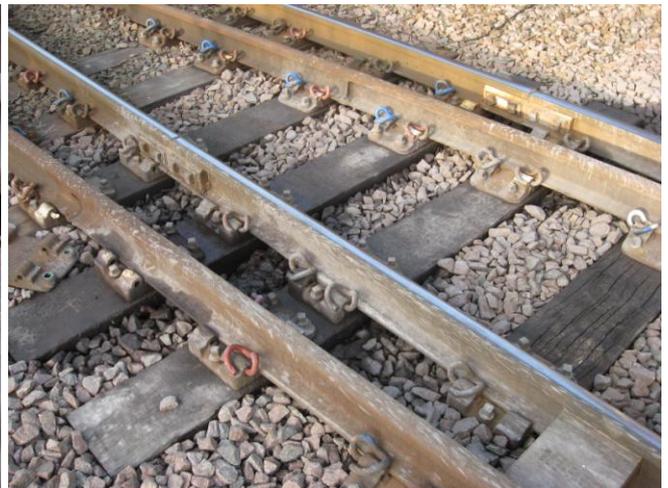
Figure 1a: Wet beds caused by voiding (where water is 'pumped' up to the surface by bouncing).

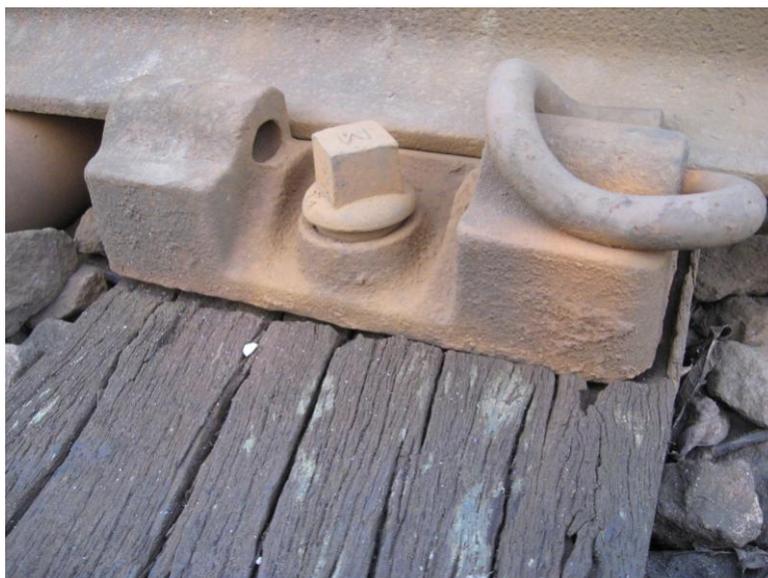
The effects of voiding may become apparent but may be caused by 'sleeper indentation', this is where the chairs become loose and embed themselves into the sleeper, this will cause the track to bounce and simulate the effects of voiding.

Figure 2: Indented sleeper and sunken chair.

The only solution to this is to renew the sleeper. (See below).

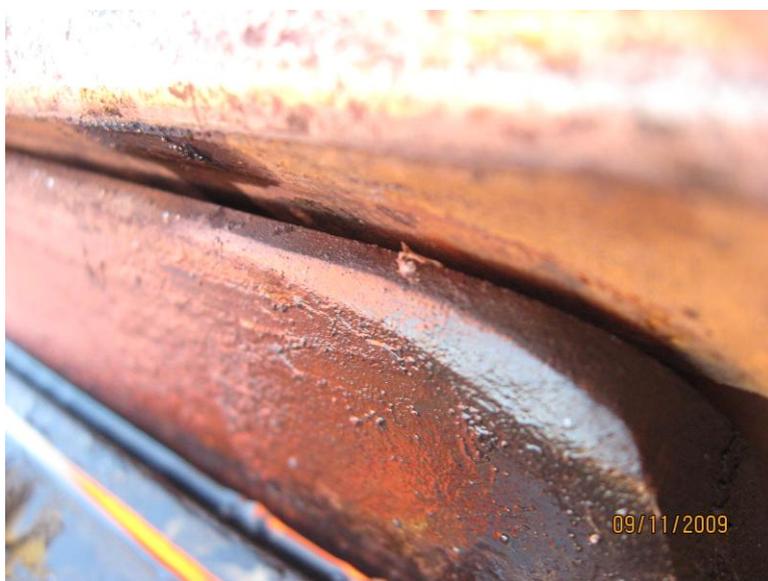
If this is compromised then it can cause the points to fail, for instance, if the switch rail fits up at the second chair because the gauge is tighter there than at the front chair and therefore it is stood off over the front chair, the points may fail to lock (see figure 2).

Figure 3: Switch rail stood-off 2mm at front when closed.

This is becoming quite common and can especially be a problem with clamplocks and mechanical points as these have less pressure to close the switch rail than machine operated points.

The gauge indifference can be the result of several things, such as incorrectly drilled sleepers, roadspread, uneven/poor rail grinding or even incorrectly fitted stretchers in which the stretchers may be preventing the switch rail from fitting up.

Re-gauging of the points is necessary (i.e: new sleepers), or temporary packing may be used, this is either 'web liners' behind the chairs to alter the gauge or temporary S&T fender shims (*for points fitted with fender only*), available in 1mm & 3mm sizes to enable the point blade to fit up at the front better.

The maximum allowable packing for web liners is 5mm & for fender shims is 3mm.

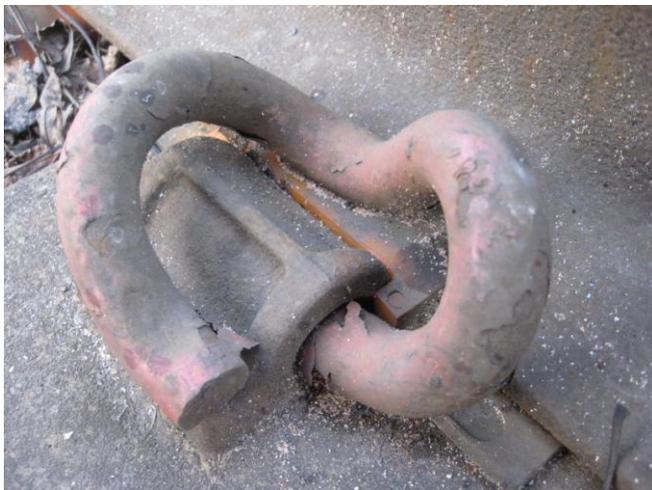
Figure 4: Correctly installed nylon

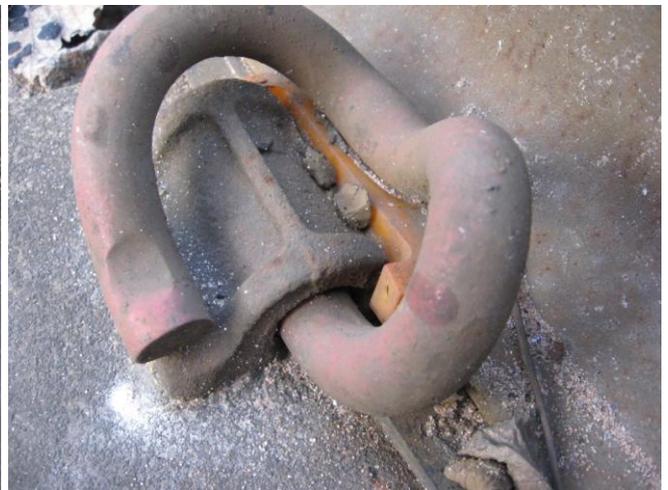
The orange nylons that are fitted beneath the Pandrol clips play an important role when fitted to the sleepers in front of the points. If the nylons are displaced, either during installation or over time the points can become wide at the toe - see below.

Figure 4a: Displaced nylon

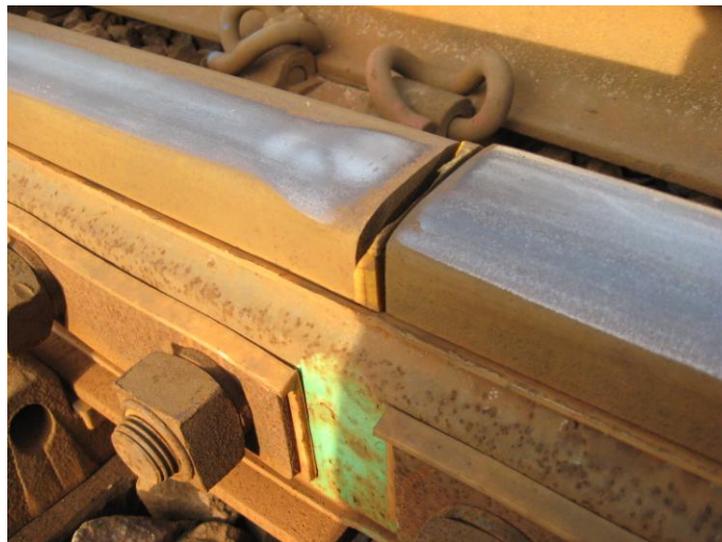
The vibrations from DJ's can be quite severe and may cause the detection to 'blob'.

The picture below is of a dipped joint – notice the left-hand rail has a wear spot caused by the train wheel hitting it hard.

Figure 5: Dipped rail joint (this is an IBJ and has shattered the insulated 'T' piece in the centre).

Lifting and packing either by shovel or Kango's is the immediate preventative measure.

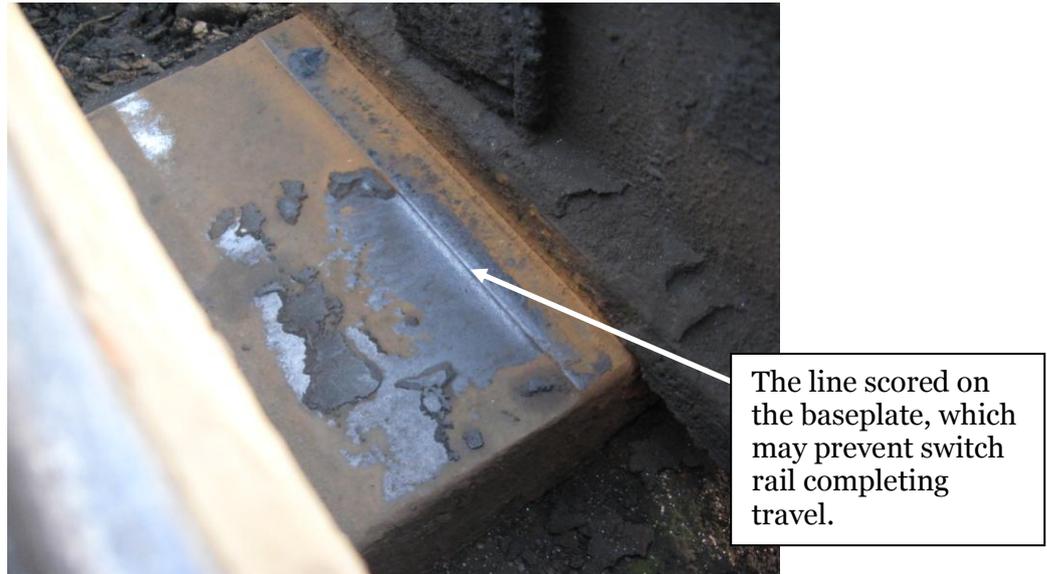
It is usually caused by a twisted switch blade digging into the slide chairs or a switch blade constantly closing with the passage of a train if the RSO is particularly large or no backdrive is fitted.

Pictured below is a chair affected by 'gaul' in the first stages.

Figure 6: Chair Gaul

The cure after it has occurred is to grind the slide chairs or to replace the nylon baseplate tops (if these are fitted), and then to prevent it happening again.
